# RCRA Compliance Evaluation Inspection (CEI) Report

Hecla Mining Company

Date of Inspection: September 24, 2003

Type of Inspection: Compliance Evaluation Inspection

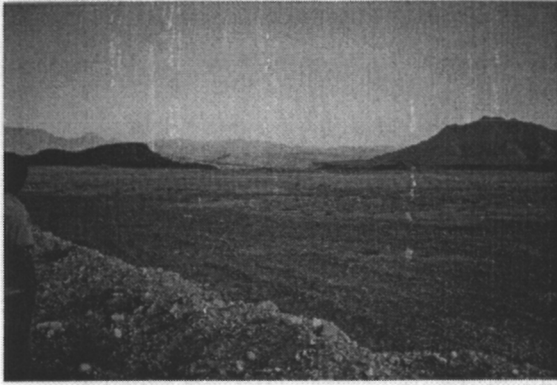
**Figure 1 :** Pond #2 (wastepile).

waste materials from earlier mining activities and adjacent evaporation pond (Figure 1). Pond #2 contains an open leachate collection trench partially constructed around its southwest side that collects runoff and drains it into the evaporation pond also located on its southwest side.

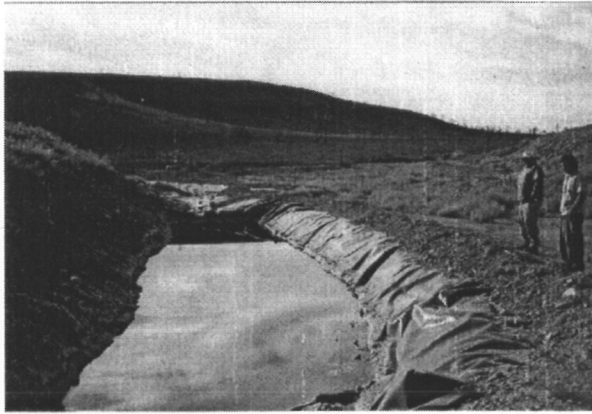
At the time of the inspection, leachate from Pond #2 appeared to be seeping into the open leachate collection trench partially constructed around its southwest side. The exact source of the liquid/leachate was hard to determine, because the liquids could have been from rain water. All of the leachate appeared to be contained within the structure. There was no evidence of these liquids overflowing outside of the ponds (Figure 2)..

**Figure 2 : Leachate collection ditch**

Surface drainage is directed around the leachate containment ponds. Pond #2 is partially capped with soil from construction of ponds 3B and 3C in a dome-shaped cover. The cover is designed to control leachate collection of the wet waste materials by forcing the waste liquids out of Pond #2 into a small lined trench. The trench flows into a small lined evaporation pond adjacent to Pond #2. The liner for both the trench and evaporation pond is high-density polyethylene (HDPE) and was in good condition.
